# Minimally invasive peri-implant procedures to obtain esthetics in the transmucosal profile

## Abstract

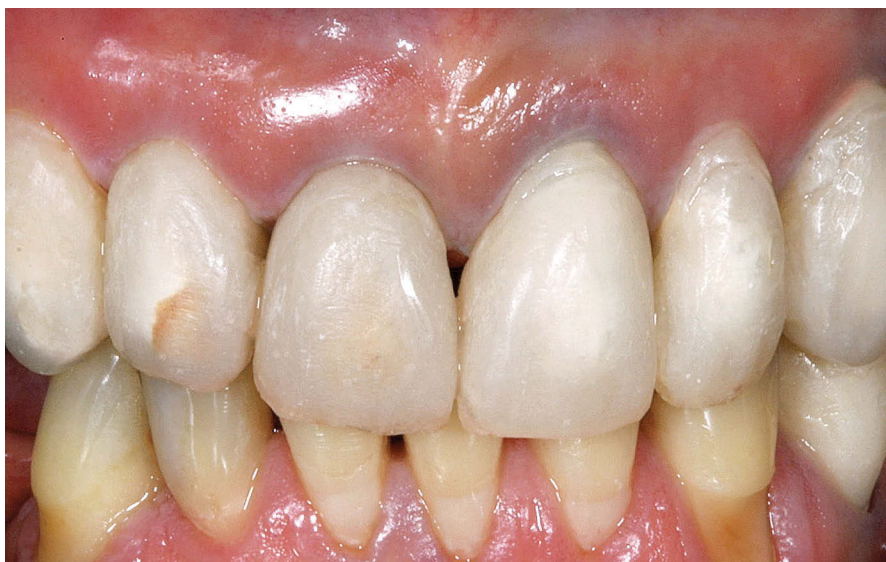
**Figure 1** - Initial clinical image.

A female patient sought a private clinic for prosthetic rehabilitation treatment. The treatment planning aimed to rehabilitate the upper teeth with metal-ceramic crowns (Fig 1). After installation of provisional crowns in teeth #13 to #23, mobility and the presence of root fracture were observed in tooth #11 (Fig 2).

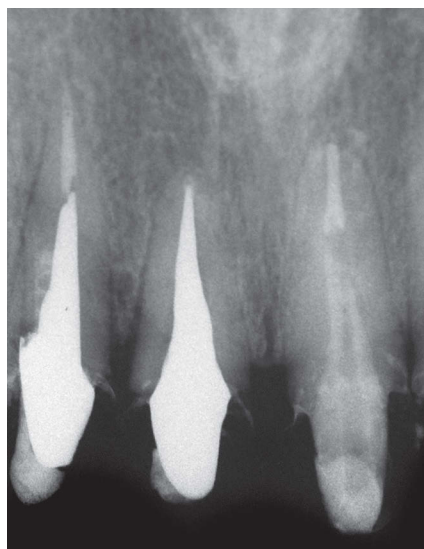
**Figure 2** - Initial periapical radiograph.

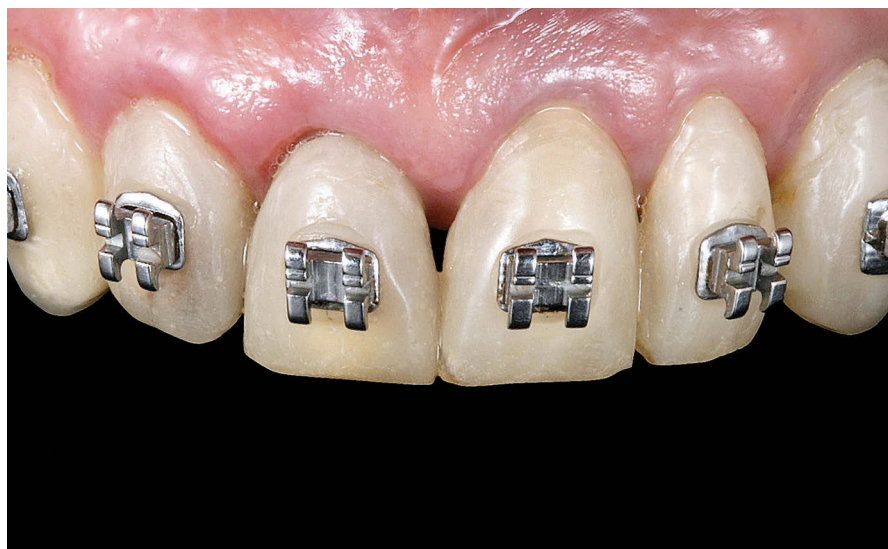
**Figure 3** - Clinical result after slow orthodontic extrusion of tooth #11.

In order to avoid proximal bone loss that could affect the esthetic outcome of the case, it was decided to conduct orthodontic treatment, with the purpose of extruding the failed tooth prior to beginning implantation in the area. After orthodontic movement (Fig 3), it was possible to extrude tooth #11 so as its gingival margin was approximately 3 mm below its homologous tooth.<sup>21</sup>

The slow orthodontic extrusion is a tooth movement technique that induces the formation of periodontal supporting tissues,<sup>5</sup> leveling the height of the gingival base and promoting the recovery of the gingival papillae.<sup>6,7</sup> This technique was chosen because there were signs of fracture in the root of tooth #11, and consequently, the presence of bone defects.<sup>8</sup>

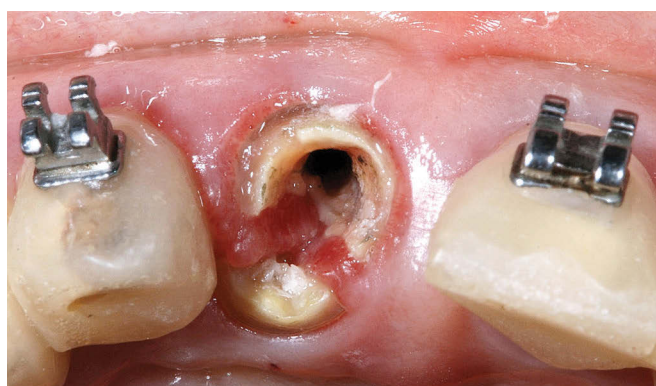
**Figure 4** - Dental root after the removing the provisional crown and the metal post.

The crown and the post were removed (Fig 4) for minimally traumatic extraction of tooth #11 and for socket inspection. The existing bone defect was small and located in the lingual face of the socket. A locking taper implant (Kopp, Curitiba - Brazil) was installed and the gap between the socket and the implant was filled with Bio-Oss biomaterial. It was closed with a polymer healing plug 2 mm in height, and a Collatape membrane was used to cover the biomaterial.<sup>4</sup> During the same session, the implant and its respective healing plug were installed in the region of tooth #24. A new set of provisional crowns was installed in the upper anterior teeth, so as to unite teeth #21 to #12 in a fixed bridge, ensuring that the pontic maintained its support of the gingival tissue and aided the closing of the alveolus (Fig 5).

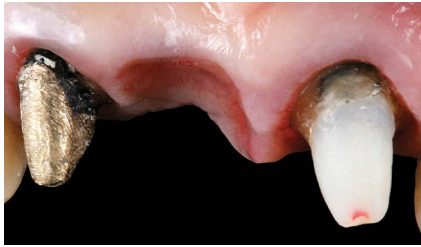
**Figure 6, 7** - After epithelial healing of the implant area, we can see the gingival profile outcome obtained with the provisional prosthetic pontic.

Four months after implantation (Figs 6 and 7), the implant of region #11 was reopened with a palatal semi-lunar supra-crestal incision (Fig 8) and the healing plug was removed so that it could be replaced by another one 6 mm in height (Fig 9). The latter was customized and its surface was previously made coarse

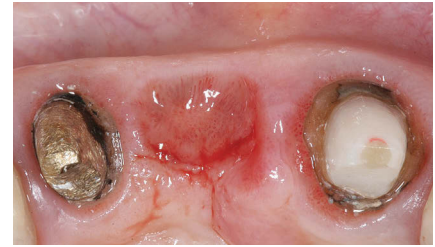
**Figure 8** - Occlusal image of the supra-crestal semilunar incision.

Another important point that should be highlighted is the change in the incision during the step of reopening the implant. The advantage of a supracrestal incision over a punch instrument incision is that the former maintains the keratinous gingival tissue. The detail is in the semilunar shape that faces the palate. This provided a greater amount of tissue buccally flaped, increasing the soft tissue in the buccal and cervical portions.<sup>19</sup> There was no rupture of adjacent papillae while trying to prevent them from being damaged and lost.<sup>20</sup>

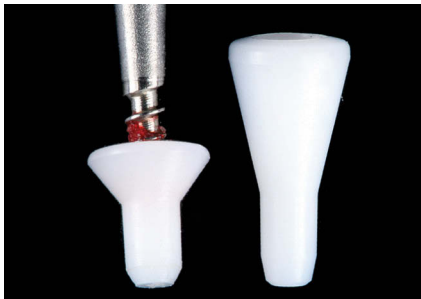
**Figure 9** - Comparison between the healing plugs before customization.

In this case report, the customization of the gingival profile was initiated with the healing plug and not with the temporary crown, as it is usually done. This is because of the material of which the healing plug is made: a polymer susceptible to being worn down, scratched or enlarged with a composite resin.

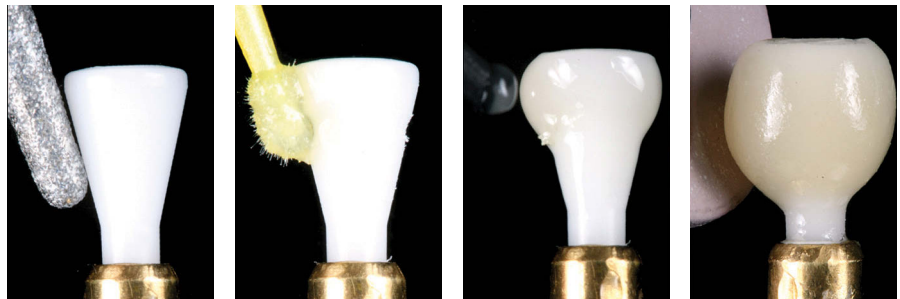
**Figure 10** - Customization and polishing of the healing plug.

by means of burs. Additionally, it was enlarged on the sides with a light-curing composite resin (Fig 10). At the end of customization, a new profile was obtained (Fig 11), which allowed the flap to buccally shift, creating an increase in buccal soft tissue and in the cervical region (Figs 12 to 15).

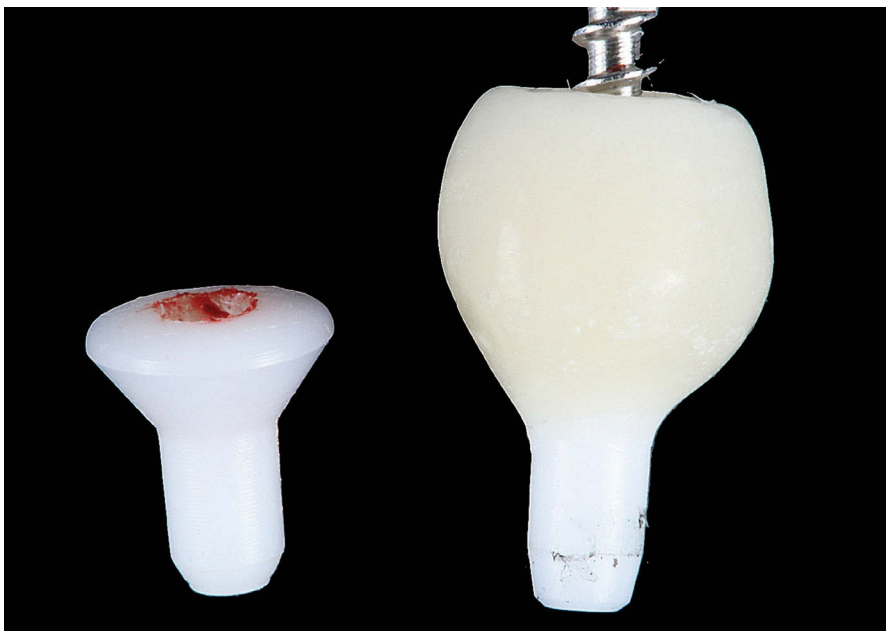
**Figure 11** - Comparison between the healing plugs after customization.

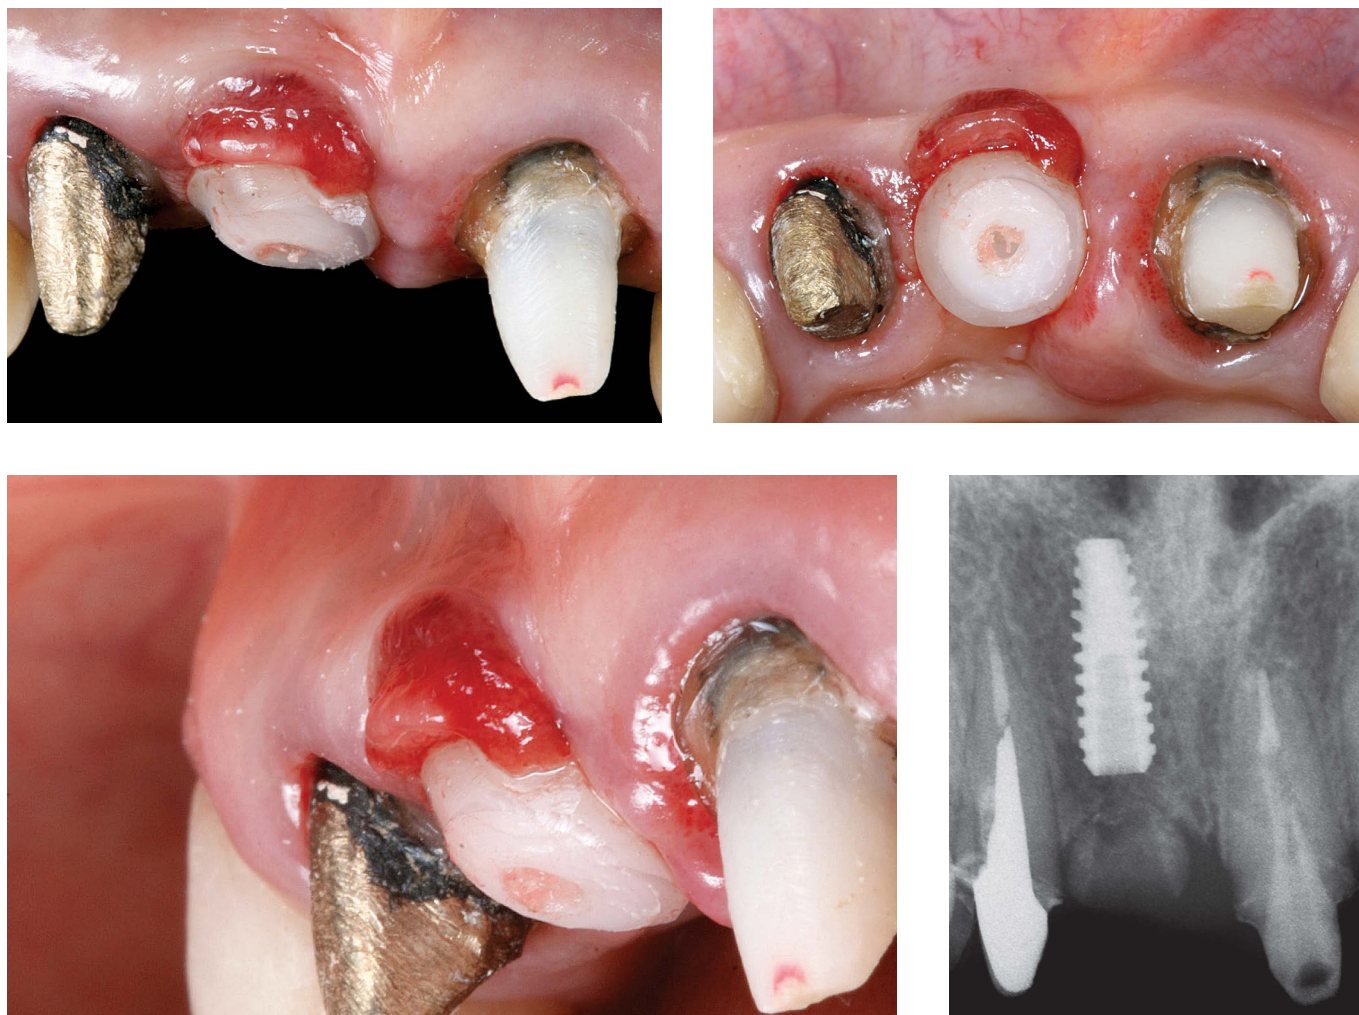
**Figures 12, 13, 14, 15** - After the insertion of the new customized healing plug. Periapical radiograph after healing plug customization.

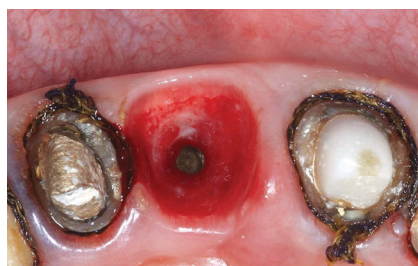
**Figures 18, 19, 20** - Frontal and occlusal images before the implant impression.

transferred by using a laboratory putty silicone matrix and a titanium transfer/abutment with acrylic resin (Fig 17). Afterwards, it was shaped with Polyvinyl siloxane using the double cord and closed tray techniques (Figs 18, 19 and 20).

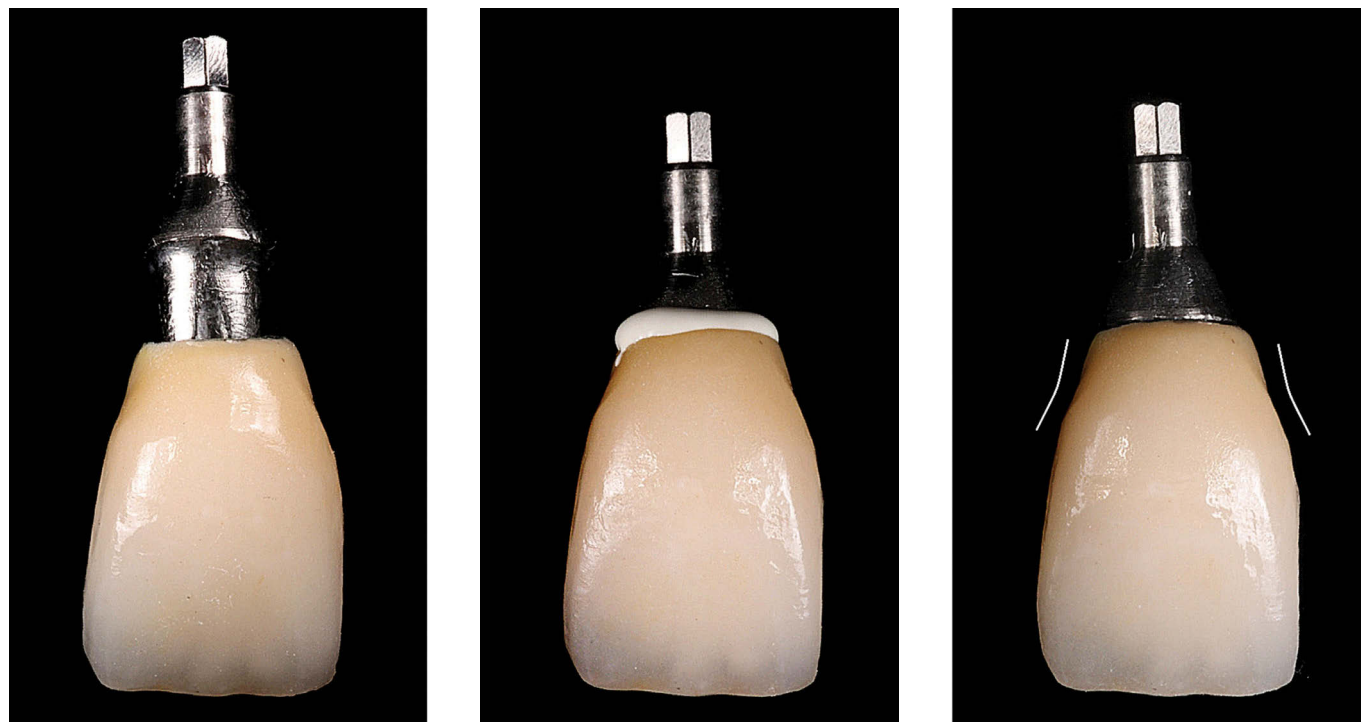
**Figure 21** - Extraoral luting of the crown and implant abutment as well as removal of excess zinc phosphate cement.

The crowns for teeth #13, 12, 21, 22 and 23 were tested and then luted by inserting the retractor cord. The crown for #11 was tested and extra-orally luted with zinc phosphate cement. The excess cement was removed (Fig 21) and the integrated crown/abutment was activated by means of an acrylic resin guide. This guide was used to direct the activation force which must be consistent over the long axis of the implant (Figs 22 to 24). This direction prevents inadequate activation of the integrated crown/abutment, which would make the connection susceptible to failure and looseness.

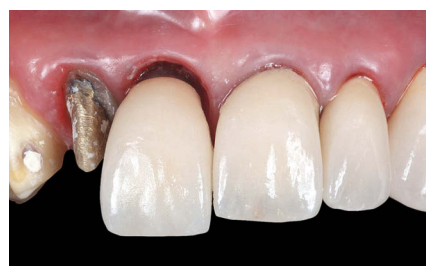
**Figure 22** - Inserting the integrated crown/abutment in tooth #11 implant.

The prosthetic implant connection used was the Locking Taper connection, a screwless connection that frictionally links the abutment and the implant in a cold metal welding.<sup>15</sup> This connection has a bacterial seal,<sup>16</sup> it allows extra-oral luting and peri-implant bone stability,<sup>17</sup> provided that the integrated crown-abutment is correctly inserted and activated on the implant.

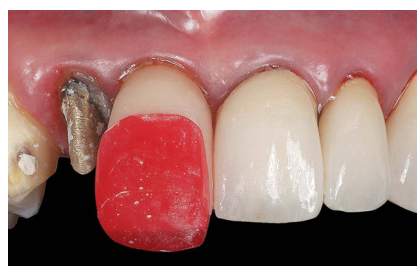
**Figure 23** - Placing the acrylic resin guide in the implant crown.

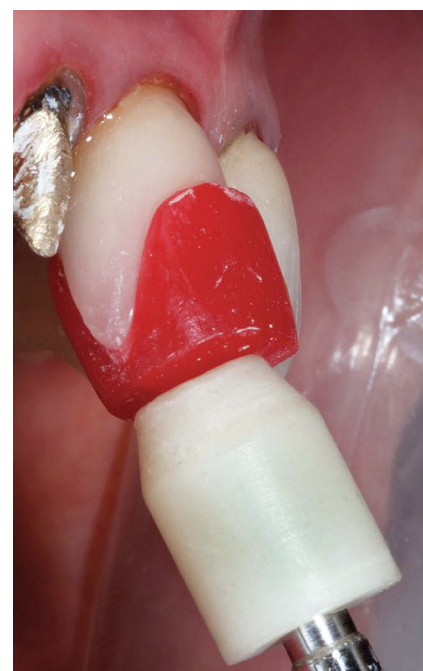
**Figure 24** - Proximal view of the acrylic resin guide used to direct the activation force.

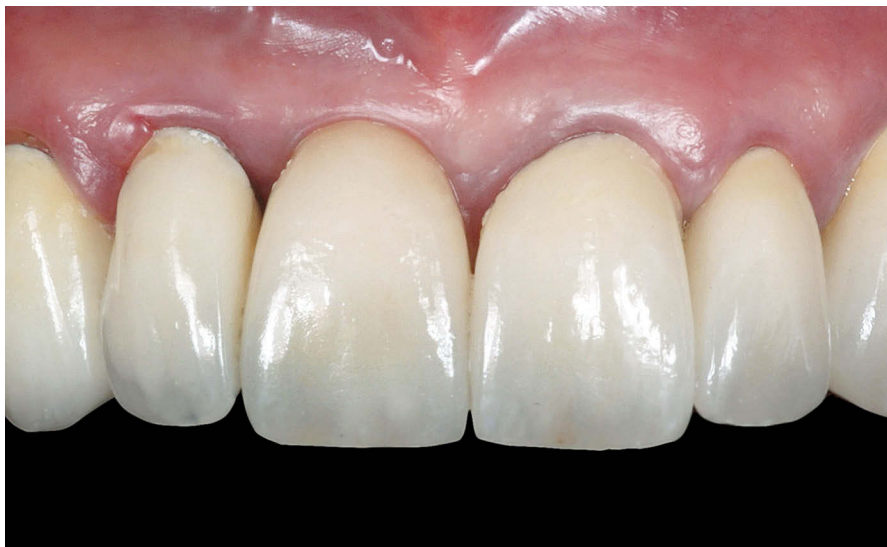
**Figure 25** - Clinical case outcome soon after all metal-ceramic crowns had been luted.

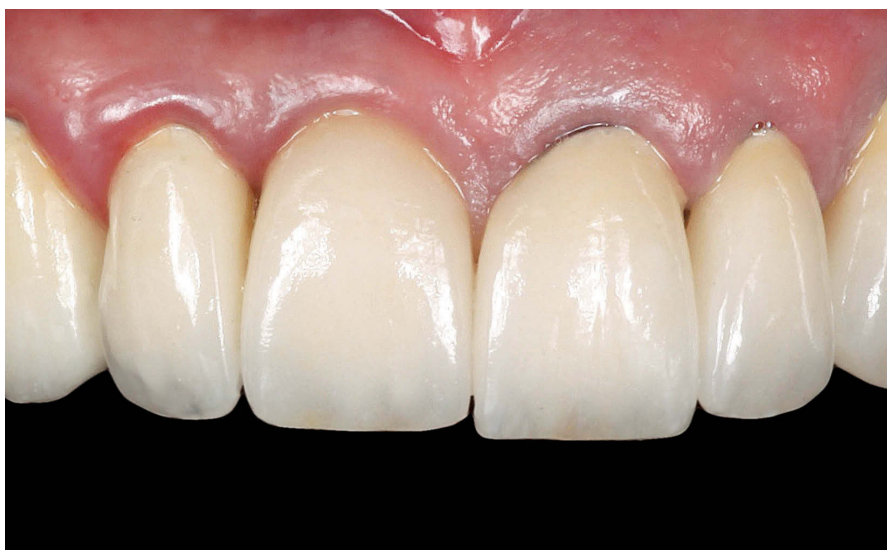
**Figure 27** - Clinical case after one year.

After one year, new periapical radiographs and an intraoral photo of the case were taken (Figs 27 and 28). Healthy and stable peri-implant mucosal tissue was observed, and the difference between the incisal edges of the incisors was of approximately 0.5 mm. Occlusal contacts were checked and adjusted.
